Evaluation Trial of MEMS Devices by LSI Process Diagnostics

Reliability Technology Department, Oki Engineering Co., Ltd., Japan

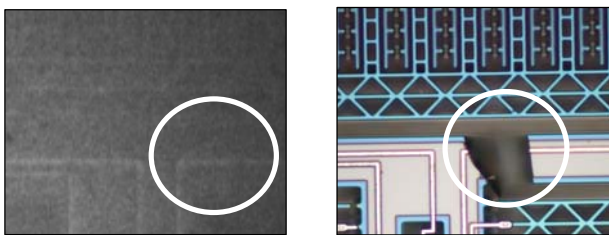
Figure 2.2: Chip internal structure before and after Si cap removal

An inspection prior to Si cap removal with an infrared microscope was developed. The presence of an abnormality of Si cap internal structure could be observed with this inspection technique. As a result, the cause of damage by deprocessing vs. processing could be determined. Figure 2.2 shows a chip internal structure before and after the Si cap removal. Damage is not observed before the Si cap is removed. However, after the cap is removed, damage is observed. Therefore, the damage was generated by the Si cap removal.

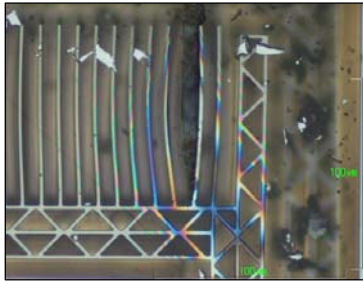
Figure 2.4:
Structure transformed by remaining bubble (OM image)

If grinding reaches the sensor the sensor breaks if not properly supported. Monitoring the grinding progress is important to prevent breakage of the sensor. Because the structure is complex, a bubble might remain in the resin around the sensor. Therefore, vacuum degassing is indispensable. During vacuum degassing, there is a possibility that the sensor is broken by the bubble. The viscosity of the resin must be monitored to prevent breakage. In initial investigations, the vacuum degassing processing of the resin was done under the normal temperature conditions. As a result, the transformation of an internal structure by the bubble was observed as shown in Fig. 2.4.

This phenomenon can be reduced by the use of a low viscosity resin and/or reducing the viscosity by raising the temperature of the resin. The sectional inspection in the structure of the MEMS machine becomes possible by proper use of the fill material.

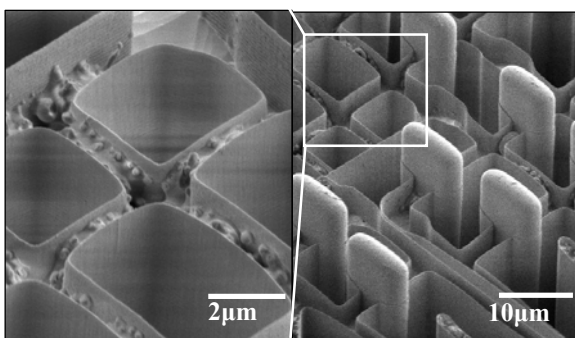
Figure 3.2: bird's-eye view SEM image on the back of the sensor

A shape that had dented the back side of the sensor was observed. When the sensor is etched, this shape is formed during etching the back by surplus gas. Moreover, the residue of the etching was on the side in the part. The residue is flimsily. There is a possibility that the MEMS doesn't function normally if this residue drops out and touches the sensor. The

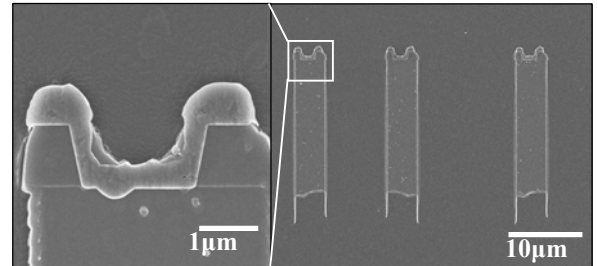
Figure 3.3: cross-sectional SEM image of the MEMS structure

Wave-like shape that originated in deep etching was observed on the side of the sensor. The residue was observed under the structure side.

The coverage of the metal wiring contact formed on the sensor was good. An alloy spike was observed with two or more contact joints. The alloy spike is generated as the Si substrate reacts to heat-treatment of the metal wiring. In LSI devices, it is necessary to note a leakage current is generated when the alloy spike exceeds the diffused region. However, it seems to be inconsequential because a diffusion zone is not formed in the sensor of this MEMS device. Thus, even if it is a defect in the process of an LSI device, the same defect is not necessarily judged a problem for MEMS. It is necessary to construct a defect judgment criterion of the MEMS device carefully because there might be other such cases.

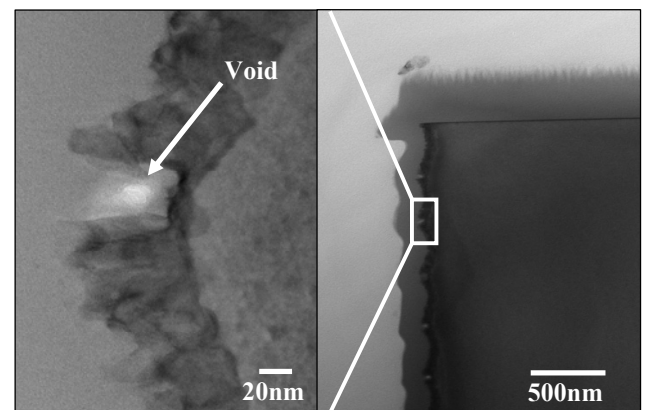
Figure 3.4: cross-sectional TEM image of the MEMS structure

As a result of cross-sectional TEM inspection, the sensor was formed by monocrystalline Si. Moreover, it was confirmed by elementary analysis that the film on the sensor side was an oxide. Moreover, an amorphous layer and minute void were observed in an interfacial part of monocrystalline Si and the oxide film. This amorphous layer is thought to be a damage layer formed by the etching. Note that there is a possibility the void may become the starting point of cleavage breaking with when a big stress is applied.

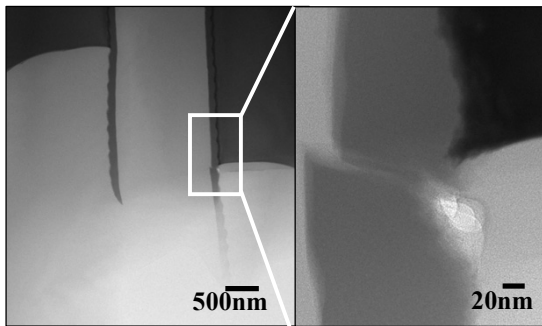
Figure 3.5: Cross-sectional TEM image of filmy residue

Moreover, the thin film under the structure side that had been observed by cross-sectional SEM inspection was a residue of the oxide film that had been formed on the side. The residue that had been broken from the root as shown in Fig. 3.5 was observed. This damage might have been generated by stress when the sample was made. However, if device with such residue is dropped, the MEMS might start to fail. Therefore, it is necessary to care when handling devices.

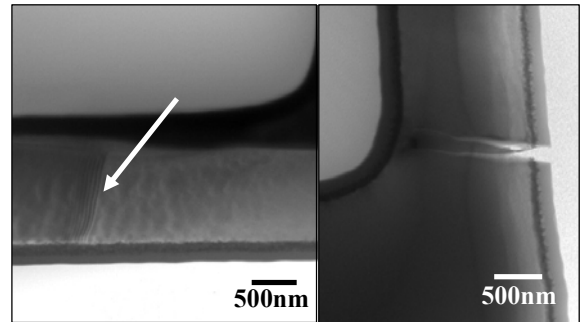
Figure 3.6: Plane TEM image in structure support part

Next, plane TEM observation was performed. Figure 3.6 shows plane TEM image in the sensor support. The left figure is an image in the vicinity of the root of the spring that supports the moving part. The stacking fault crosses the inside of the sensor structure (arrow part in the figure). To break the spring intentionally, stress was added to another part. The right picture of Fig. 3.6 shows the destruction of the part. The breaking part broke at the cleavage as shown in this figure. From this situation, it is presumed that the possibility of a stacking fault (shown in the left of Fig. 3.6) causing a cleavage break is high.

This stacking fault might have been generated by the stress when the sample was made. The crystal defect made by scratch damage might occur in the sample while making the TEM sample. In this case, random dislocation along the scratch line as shown in Fig. 3.7 is seen. Such a scratch often steps over the adjoining structure. Therefore, such a defect can be presumed to have originated during the making of the sample.

The stacking fault inside of the sensor structure Breaking part intentionally broken
