Evaluation Trial of MEMS Devices by LSI Process Diagnostics

Reliability Technology Department, Oki Engineering Co., Ltd., Japan

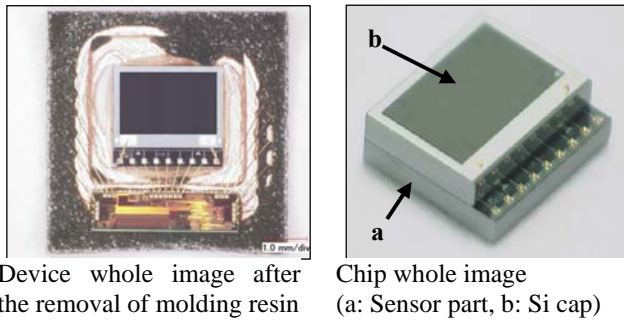
Figure 2.1: Internal structure of MEMS device

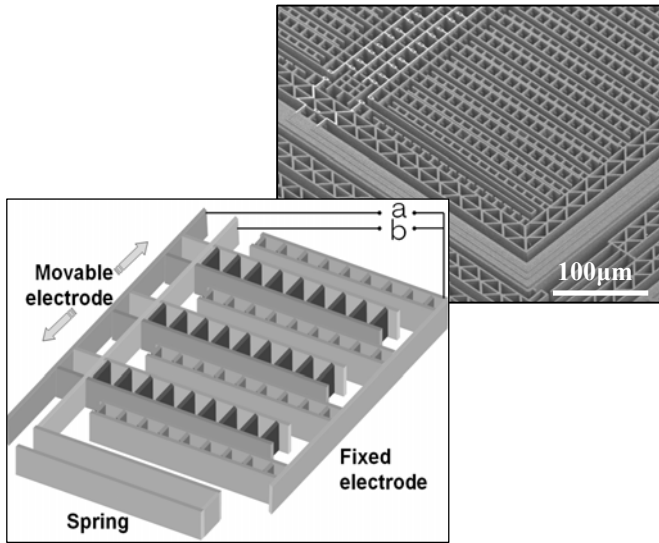
The Si cap was able to be removed by the technique described in paragraph 2.1. The sensor surface was inspected. Inspection confirmed that the sample used electrostatic capacitance to detect acceleration. Figure 3.1 is a bird's-eye view SEM image of the device and a chart explaining the operation of the sensor.

Figure 3.1: bird's-eye view SEM image and the operation explanation chart of the sensor
